***HILLTOP RETAIL CENTER
GLENDALE HEIGHTS, ILLINOIS***

*Property Management & Leasing
Evaluation & Recommendation Report*

January 11, 2006

PROPERTY EVALUATION & RECOMMENDATIONS

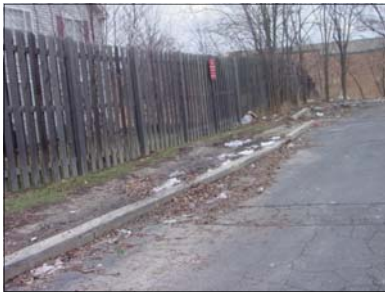
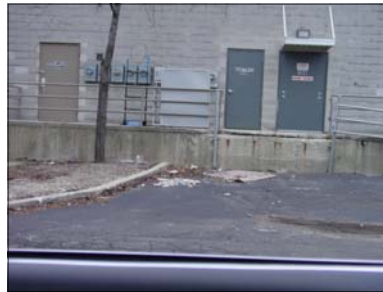
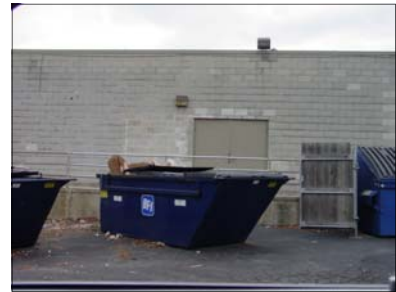
The overall condition of the exterior grounds was fair on the date of inspection. There was a moderate amount of debris throughout the parking lot and storefront sidewalk areas. The Management Team strongly recommends installing approximately six (6) commercial grade, aggregate garbage can receptacles along the storefront sidewalk. This will provide patrons the option of disposing their debris rather than throwing it on the ground. The initial expense will save a tremendous amount of operating expense to clean the property.

Ownership should consider an initial “clean up” of the exterior grounds, as well as implementing a bi-weekly inspection/debris removal program. A property of this size and nature generally requires a “clean up” two times per week.

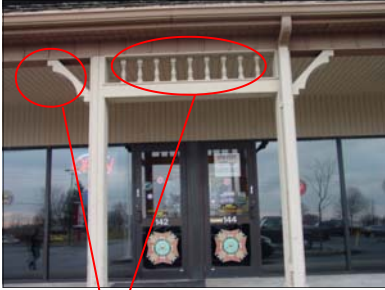
REMOVE

1. Remove the iron picketed lattice that runs along the façade roof line.
2. Remove the wood spindles between storefront columns and forty five degree supports at either side.
3. Re-finish and paint all storefront wooden columns. Color should contrast with the front and side elevations. Also, paint all exterior window shutters.
4. Provide a rental abatement to the Village Hut in an amount sufficient enough to purchase a new vinyl entrance canopy system. This should be subject to Landlord approval for design, color, etc. The color should remain consistent with the property’s aesthetic appearance.
5. Rebuild/repair and paint six (6) garbage receptacle enclosures.
6. Paint all brick and block—front and side elevations. The Management Team recommends a Taupe or Beige color so that it remains timeless and neutral.
7. Paint all cedar fascia and soffit to match columns.

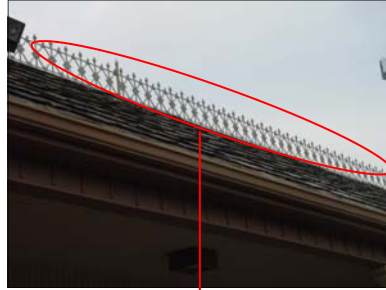
REMOVE

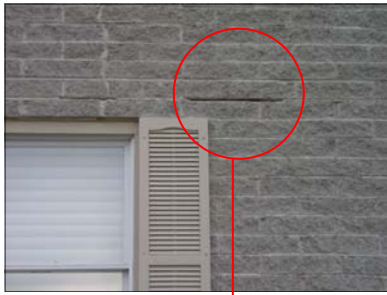
Tuck-Point

1. There is a moderate amount of tuck-point work that should be conducted to eliminate further damage and cost. The repairs should be conducted on block and brick portions of the property.

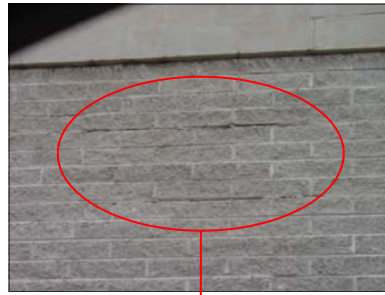
Tuck-Point

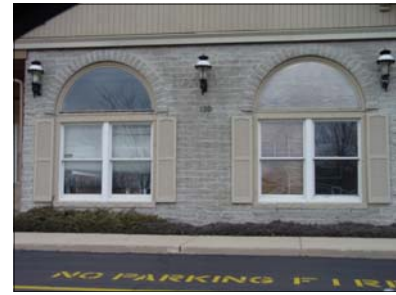
Paint Shutters

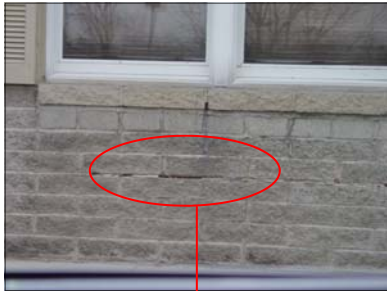
Tuck-Point

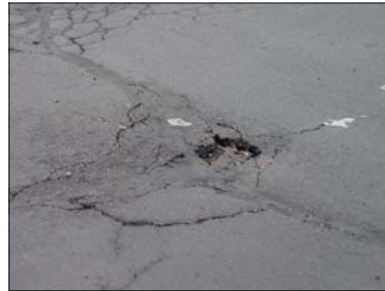
Asphalt Repairs

3. There are several areas of asphalt that require serious repair. Most areas can be temporarily repaired by installing cold patch material.
4. The Management Team recommends labeling all of the back doors at the property for identity purposes.

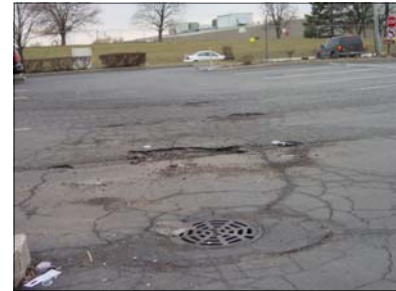
Asphalt Repairs

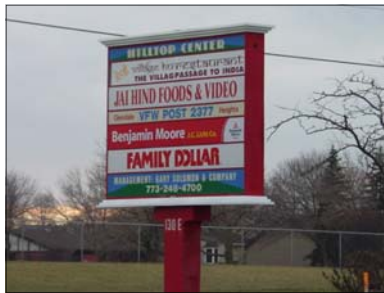
Marquee Sign

2. The marquee pylon sign located in front of the property still displays the previous management/leasing name and contact information. The information should be updated immediately.

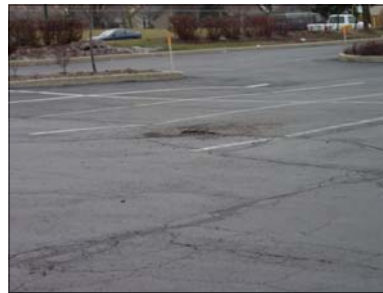
Asphalt Repairs
